ECE1200 Silicon Errata and Data Sheet Clarification

Device Errata Issues

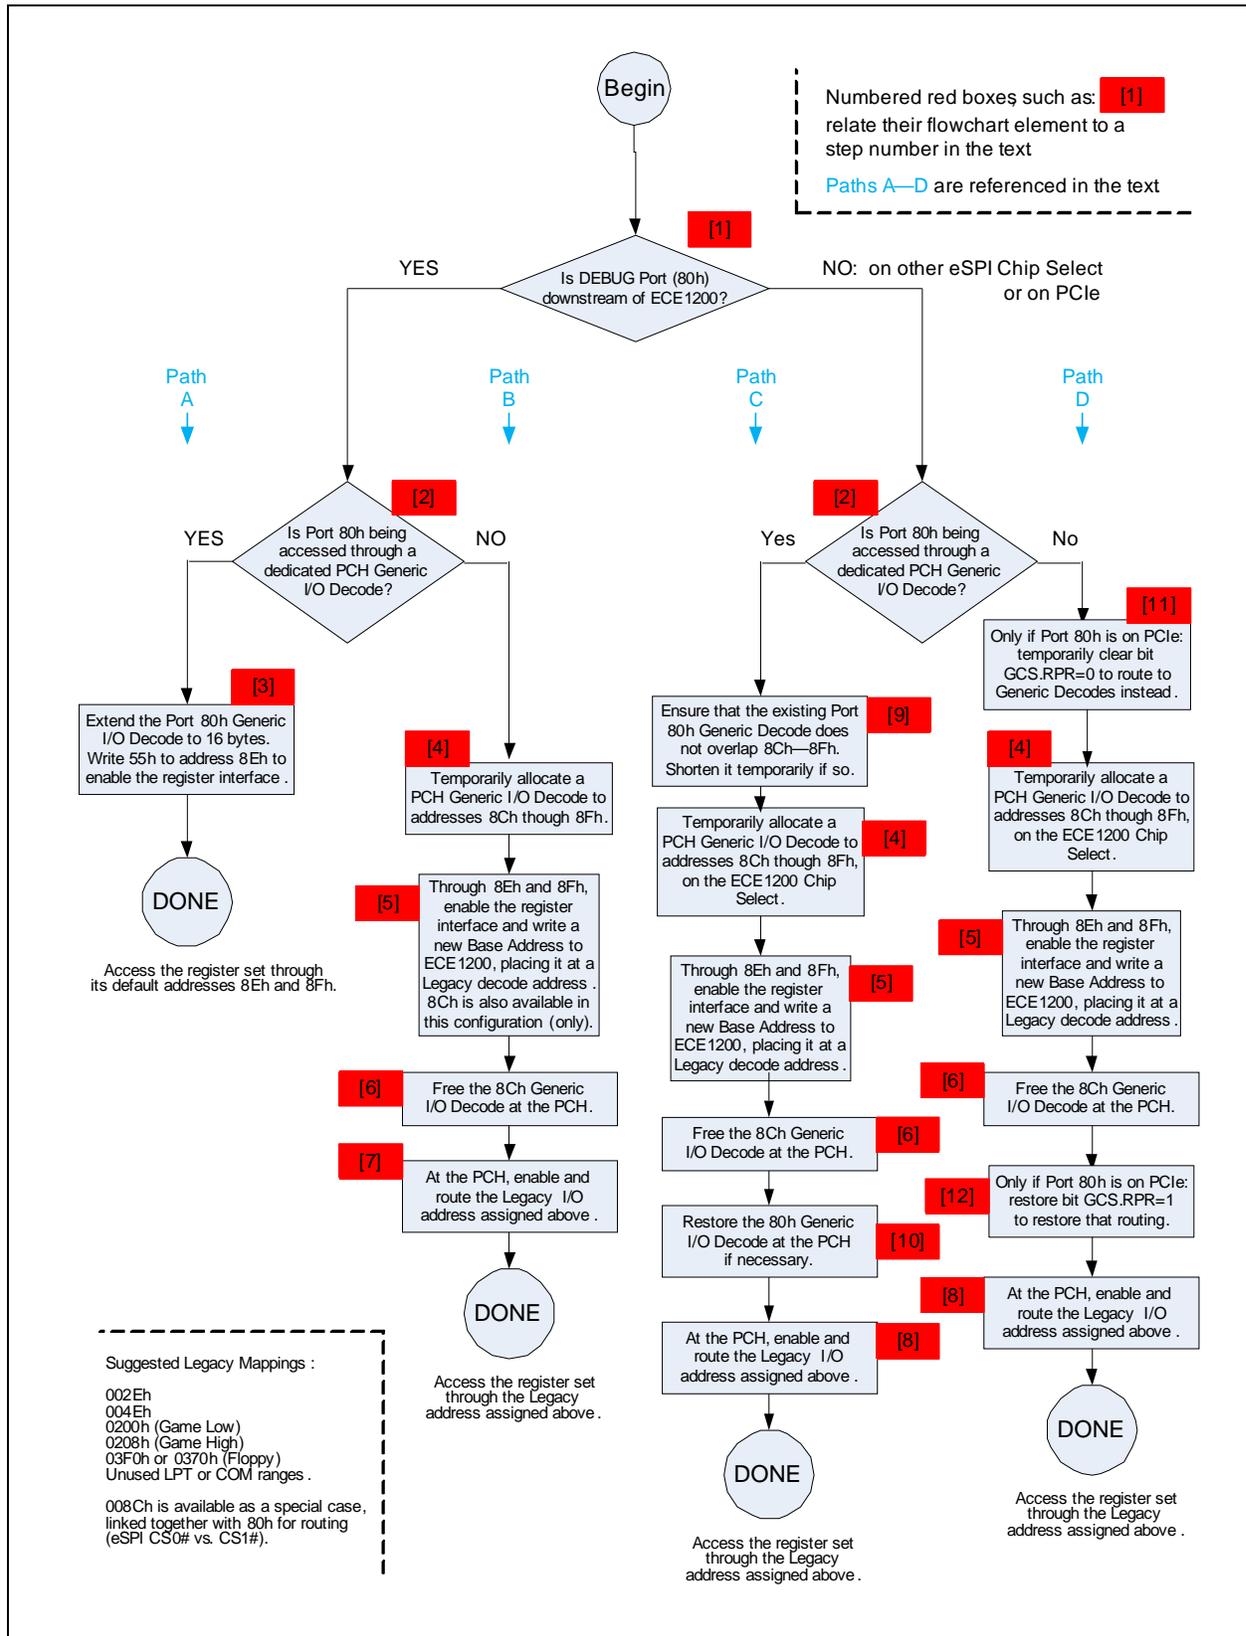
FIGURE 1: INITIALIZATION SEQUENCES FOR REGISTER ACCESS

It has been discovered that an initial I/O Base Address of 008Eh for this device makes the DATA register (at 8Fh) not easily accessible through the Host Chipset in some system configurations. Starting with Functional Revision B, this address is changed to 008Ch, placing INDEX at 8Ch and DATA at 8Dh. The data sheet release is now edited to document the much simpler initialization requirements resulting from it. The old initialization requirements are given in the Work Around section below.

By default, it is mapped to an unused section of the Port 80h ("Debug Port" or "RPR") region of the I/O space, at addresses 8Eh (INDEX) and 8Fh (DATA). The address 008Eh is its initial "Base Address".

Figure 1 illustrates the sequences used in order to map the register set as desired. These are explained in more detail in the Step list below.

Referring to Figure 1, the first two decisions, Step [1] and Step [2], separate the initialization process into one of four “Paths”, Path A through Path D. These are based on the intended system mapping of the Port 80h (“Debug Port” or “RPR”) I/O region.
